DEPARTMENT OF TRANSPORTATION**DIVISION OF ENGINEERING SERVICES**

Contract #: 04-0120F4Cty: SF/ALA Rte: 80 PM: 13.2/13.9File #: 69.28**WELDING INSPECTION REPORT****Resident Engineer:**Pursell, Gary**Address:** 333 Burma Road**City:** Oakland, CA 94607**Report No:** WIR-008725**Date Inspected:** 27-Aug-2009**Project Name:** SAS Superstructure**OSM Arrival Time:** 1900**Prime Contractor:** American Bridge/Fluor Enterprises, a JV**OSM Departure Time:** 700**Contractor:** Zhenhua Port Machinery Company, Ltd (ZPMC), Changxing Island **Location:** Shanghai, China**CWI Name:** Pan Wan Long**CWI Present:** Yes No**Inspected CWI report:** Yes No N/A**Rod Oven in Use:** Yes No N/A**Electrode to specification:** Yes No N/A**Weld Procedures Followed:** Yes No N/A**Qualified Welders:** Yes No N/A**Verified Joint Fit-up:** Yes No N/A**Approved Drawings:** Yes No N/A**Approved WPS:** Yes No N/A**Delayed / Cancelled:** Yes No N/A**Bridge No:** 34-0006**Component:** OBG segments**Summary of Items Observed:**

OBG Trial assembly westline

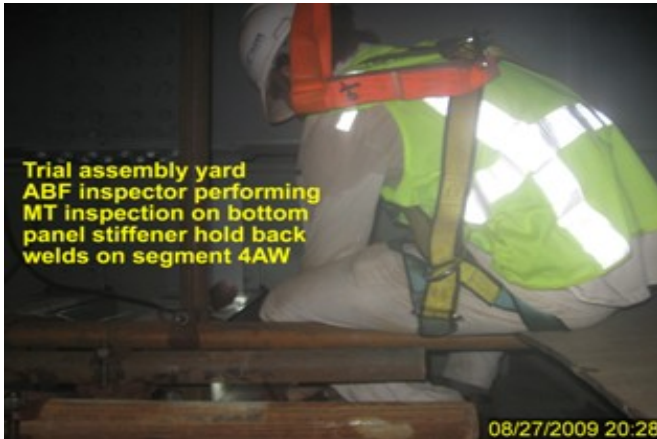
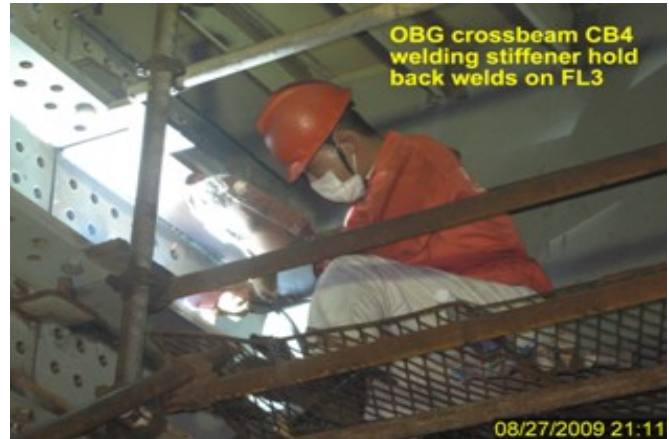
This QA observed ZPMC qualified welding personnel identified as 048801 perform FCAW welding on OBG segment 5BW weld joint identified as SSD10A-177. ZPMC QC identified as Mr. Pan Wen Long was present to monitor the welding process. The welding parameters as measured using QC's calibrated instruments appeared to be in general compliance with WPS-B-T-2132.

This QA observed ZPMC qualified welding personnel identified as 054458 perform SAW welding on OBG segment 5BE to 5CE weld joints identified as OBE5A-007 and 008. ZPMC QC identified as Mr. Pan Wen Long

was present to monitor the welding process. The welding parameters as measured using QC's calibrated instruments appeared to be in general compliance with WPS-B-T-2233-T.
